SAE International[®] INFORMATION REPORT

SAE J2949 DRAFT NOV2010

H-III50M Ankle Update to Eliminate Electrical Signal Noise

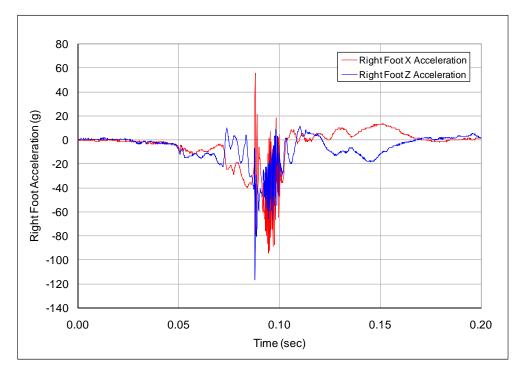
High-speed frontal crash tests conducted by IIHS with HIII50M dummy (with the 1996 version of the ankle design) have shown ringing in the foot accelerometer signals. Postcrash investigation of the dummy revealed the signal ringing was due to metal-to-metal contact between the ankle shaft and the surface just below the ankle bumper. The ringing propagates through the dummy's lower leg, which produces ringing in the tibia and femur load cell signals. The ringing can artificially increase peak injury measures, even after appropriate filtering is applied. In some cases peak injury measure timing from the lower extremity channels occur during a period of ringing in the foot accelerometer channels. In those cases, IIHS had used exclusion zones to limit the reporting of peak lower extremity injury measures to time periods occurring before or after the known time period with signal noise.

IIHS indentified the signal noise from foot accelerometer channels in high-speed frontal crash tests. Typical accelerations from the feet are shown in Figure 1.

(Test Configuration: 40 MPH into 10 inch pole, 40% offset)

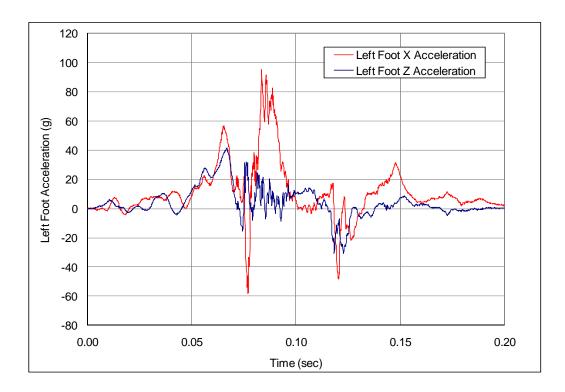
Figure 4a, Left Foot Accelerations with the New Design (Test CF09007)

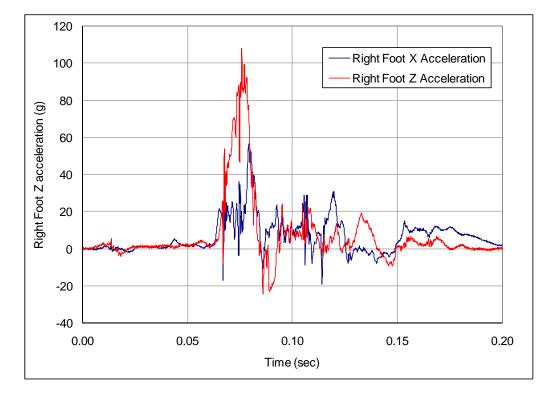
Figure 4b, Right Foot Acceleration with the New Design (CF09007)
