*[ Hybrid-III50th Head Assembly ; Chin hit Neck ]*

**Head Chin and Neck (Others and JASTI)**

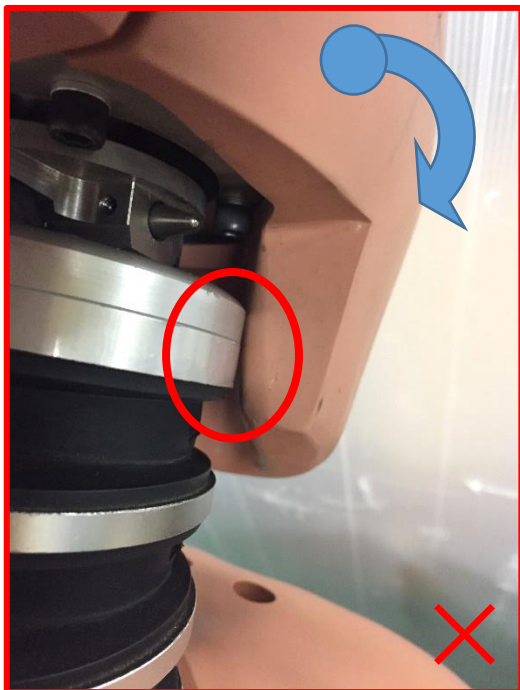
- Market reports : Hybrid-III50th Head Chin width too narrow ;  
Chin part hits the Neck by Neck Certification test or Real car crash test.,  
Head assembly should be free moving without contacting Neck.

**The cause of trouble. : Chin Inside width is narrower than Neck**

**Wrong ; Head Chin contact Neck**

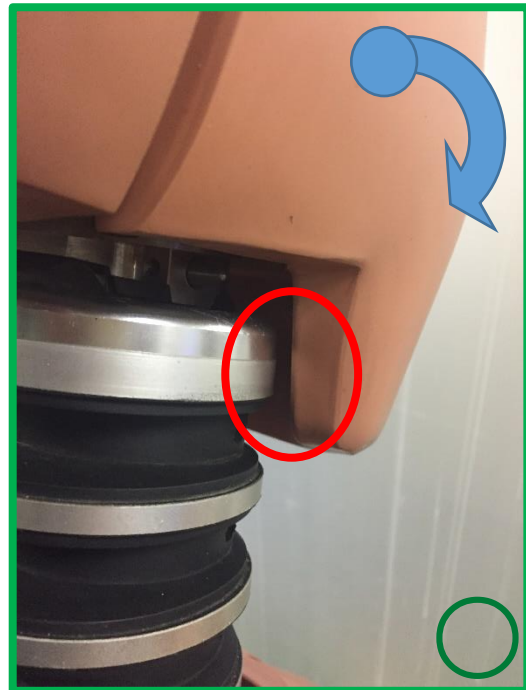
**Correct ; Head Chin is free to Neck.**

Head Assembly parts No. [780-51-61X](#) ( for 6 axis Load cell replacement.)

[78051-61XT](#) ( for 6 axis load cell replacement and Tested)
