SURFACE VEHICLE INFORMATION REPORT

MAR2015 J2949 2015-03 Issued

H-III50M Ankle Update to Eliminate Signal Noise

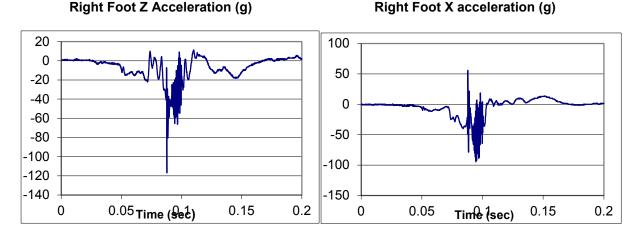
IIHS identified the signal noise from foot accelerometer channels in high-speed frontal crash tests. Typical accelerations from the feet are shown in Figure 1.

FIGURE 1 - FOOT ACCELERATIONS WITH THE ANKLE DESIGN IN 1996 NHTSA REGULATION (TEST CEF 0508)

High-speed frontal crash tests conducted by IIHS with HIII50M dummy (with the 1996 version of the ankle design) have shown signal noise in the foot accelerometer signals. Post crash investigation of the dummy revealed the noise was generated by two possible areas of the current ankle design. One is the possible metal-to-metal contact between the ankle joint ball shaft and the bumper retainer. The second location is between the ankle ball shaft and its mounting hole in the welded foot assembly. The signal noise can propagate through the dummy's lower leg, which has been shown to produce signal noise in the tibia and femur load cell signals. The signal noise can artificially increase peak injury measures, even after appropriate filtering is applied. In some cases peak injury measure timing from the lower extremity channels occur during a period of ringing in the foot accelerometer channels. In those cases, IIHS had used exclusion zones to limit the reporting of peak lower extremity injury measures to time periods occurring before or after the known time period with signal noise.

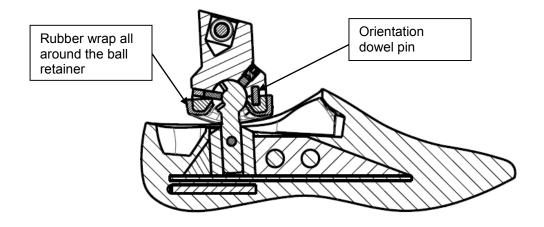
In order to prevent the metal-to-metal contact between the ball shaft and the ankle shell in the Hybrid III ankle joint, the ankle bumper metal insert and the ball retainer have been merged to allow some metal material space to be taken by rubber without changing the overall dimension of the assembly. This change eliminates metal-to-metal contact. A dowel pin/hole feature has been added to prevent the ankle bumper from being installed in the wrong orientation. Figure 2 shows the new design.

FIGURE 2 - DESIGN OF UPGRADED ANKLE JOINT

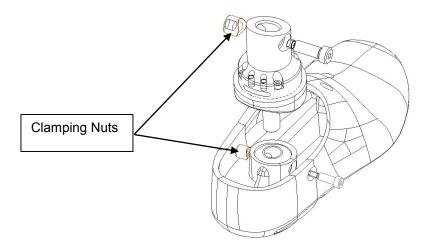
In addition to the modifications mentioned above, the ankle joint interface locations were improved to eliminate joint looseness, due to the machining tolerances specified for each part. The new design employs clamping nuts to reduce the slop, which eliminates any play at the two connection interfaces. Figure 3 shows the new ankle design with the clamping nut.

FIGURE 3 - DESIGN OF THE UPGRADED INTERFACES ABOVE AND BELOW THE ANKLE JOINT

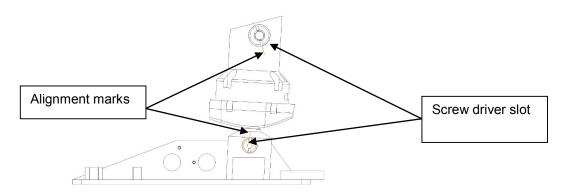
Alignment marks were designed for the ankle shell and the shell of the foot bone to assist the alignment of the clamping nut to the shaft of the tibia bone or the ball shaft, see Figure 4. These alignment marks help to prevent potential damage to the half moon feature of the clamping nut due to the misalignment.

FIGURE 4 - ALIGNMENT MARKS FOR THE CLAMPING NUTS

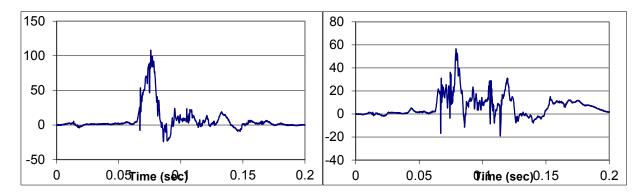
Vehicle crash tests were conducted by IIHS to verify if the new design is able to reduce or eliminate the signal noise issue as described in section 4.1.2. In each IIHS test an instrumented HIII 50M dummy was placed in the driver seating position. Figure 4 contains examples of the foot acceleration results using the new design in vehicle testing.

FIGURE 4 - FOOT ACCELERATIONS WITH THE NEW DESIGN (TEST CF09007)

Test ID	Ankle/Foot Design	Test Configuration	Vehicle Information	Accelerometer Signal Noise on Foot
CEF0508	Old	40 MPH, 40% frontal offset	2005 Chevy Uplander	Yes
CEF0507	Old	40 MPH, 40% frontal offset	2005 Ford Ranger	Minor noise
CF09004	New	30 MPH into 10 inch pole, 25% offset	2004 Chrysler Concorde	No
CF09005	New	35 MPH into 10 inch pole, 22% offset the pole	2005 Kia Rio	No
CF09006	New	40 MPH into 10 inch pole, 23% offset	2005 Kia Rio	No
CF09007	New	40 MPH into 10 inch pole, 24% offset	2004 Chrysler Concord	No

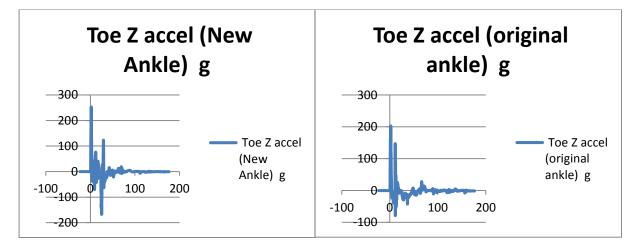
Pendulum testing was also performed comparing the original and updated HIII50M ankles. An updated European Foot Impact was used to perform the tests. It was proven difficult to achieve a similar type of signal noise found in the IIHS vehicle testing. The conclusion of this study was that the ankles appeared to be similar in impacts to the ball of the foot in a component, pendulum type of testing. Figure 5 and 6 shows an example of the results.

FIGURE 5 - EXAMPLES OF BALL OF FOOT PENDULUM IMPACTS

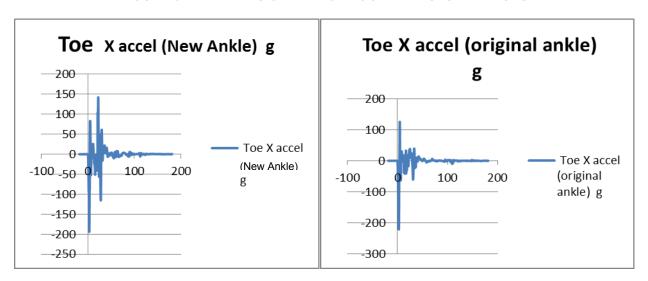
FIGURE 6 - EXAMPLES OF BALL OF FOOT PENDULUM IMPACTS
